**AIR ACCIDENT INVESTIGATION  
& AVIATION SAFETY BOARD  
(AAIASB)**

**AIRCRAFT ACCIDENT REPORT**

**HELIOS AIRWAYS FLIGHT HCY522  
BOEING 737-31S  
AT GRAMMATIKO, HELLAS  
ON 14 AUGUST 2005**

Accident of the a/c 5B-DBY of Helios Airways,  
Flight HCY522 on August 14, 2005,  
in the area of Grammatiko, Attikis,  
33 km Northwest Of Athens International Airport

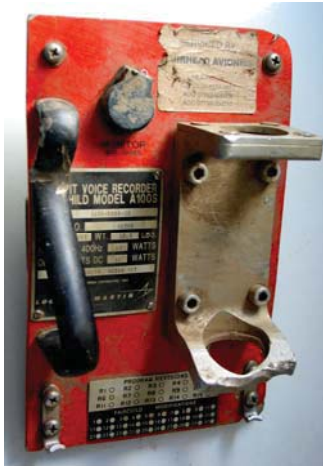
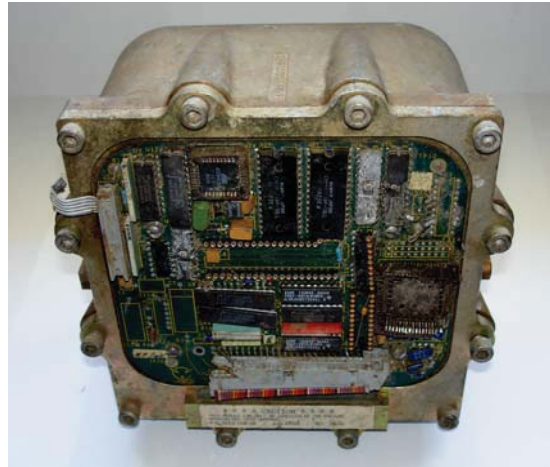
**Photo – CVR**

The CVR was taken to be transcribed at BEA (Bureau d’ Enquêtes et d’ Analyses) in France. The Flash Card Survivable Store Unit (FCSSU) was opened and the memory board was extracted. The memory board was connected to the acquisition part of the Solid State CVR by a cable from the FCSSU (memory-protected module). The cable was found in good condition; a new connector was plugged into the cable, which was then connected to BEA’S A100S unit, which was used as a reader. After the data extraction was completed, the last 30 minutes of the recording was obtained.

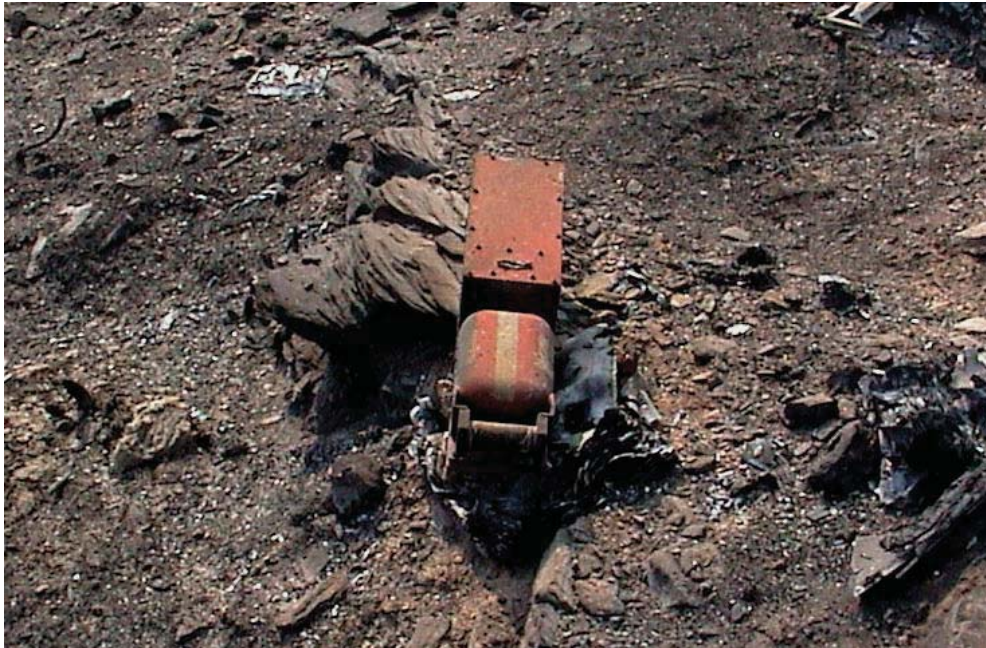
**Photo - FDR**

The FDR was found near the right aft service door and was recovered from the accident site on 14 August 2005, the day of the accident (Photo – FDR). It was taken to the readout facilities of BEA and the read out began on 17 August 2005. The recorder was in good condition, with no evidence of impact damage. However, the outside casing, including the outside of the acquisition unit, was blackened by fire expose and the paint was melted. Since it bore signs of fire exposure, the protected unit was removed from the FDR and connected to a new acquisition unit. It was then connected to the readout equipment, in order to download the raw data file. The data file was synchronized using BEA software.

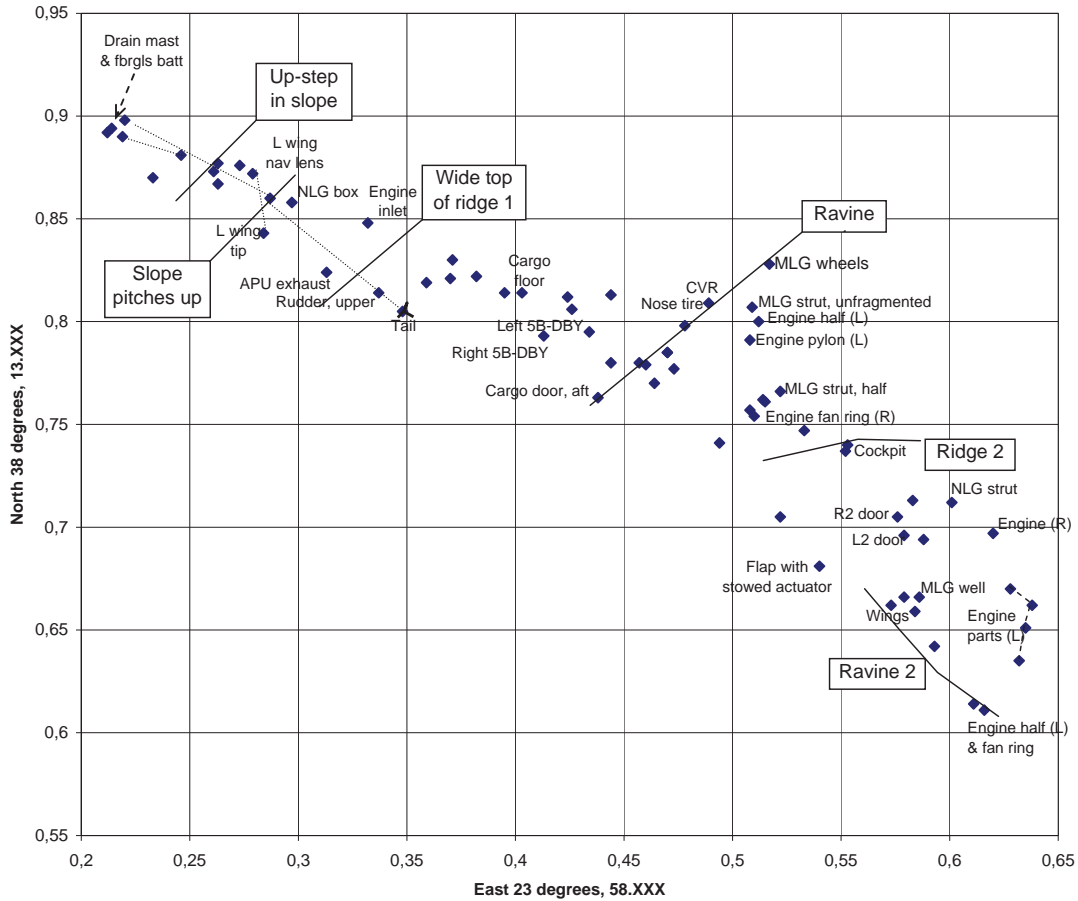
**Diagram – Wreckage Distribution Map**

The wreckage was distributed generally from west to east, over two rocky hills for a straight-line distance of about 800 m (Diagram - Wreckage Distribution Map and in Appendices the Wreckage Distribution Position Data). The first component found was a drain mast where the fuselage first impacted the ground. Tufts of fiberglass thermal-acoustic insulation batting were in the immediate area.

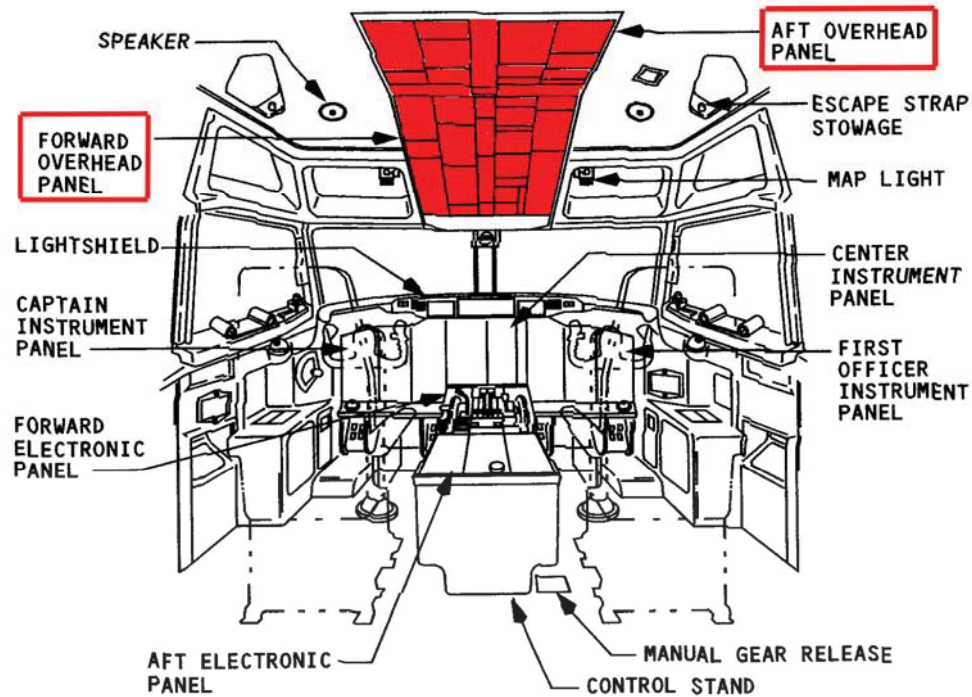
**Diagram – Position of overhead P5 panel (marked in red)**

The forward overhead P5 panel was located in the area of the cockpit within the wreckage at the accident site. The panel was accessed by removing the surrounding wreckage. Once the panel was located, low air pressure was used to remove the accumulated dirt, dust and light debris in order to visually examine the controls. The entire P5 panel was photographed and the position of the controls (toggle switches, selectors, switches, and indicators) were visually examined and documented. The controls were not activated.

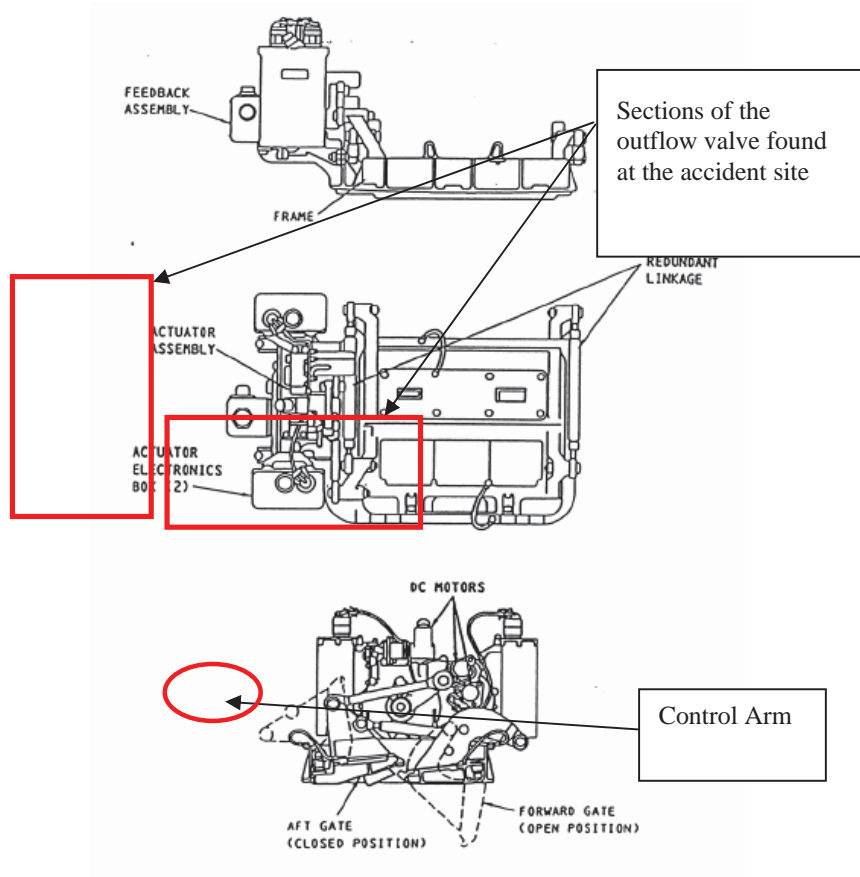
**Diagram - Aft Outflow Valve**

The actuator/motor assembly and both the forward and aft door gates of the aft outflow valve (AOV) were found at the accident site (see diagram and photos below and next page). The actuator/motor assembly was separated from each of the door gates. The condition of the actuator/motor assembly was documented and photographed at the accident site. The control arm and position indicator remained attached to the motor assembly. Using hand pressure, a small force was applied to the control arm; it was physically locked in place and not able to rotate freely. At the storage facility, a measurement was taken between the closed position stop and the control arm position lever; the distance between the two was 8.0 mm (see photo in the next page).
